Relevance of the IIHS small overlap crashtest in Europe

- DTC 149 small overlap crashtest Renault Scénic II with reduced speed
- DTC 150 IIHS small overlap crashtest Renault Scénic II
- DTC 151 crashtest two-way traffic Renault Scénic II – Landrover Freelander
- DTC 152 IIHS small overlap crashtest principle study Ford Mondeo modified

Report number: pSi-13-0130 Order number: pSi-13-0130

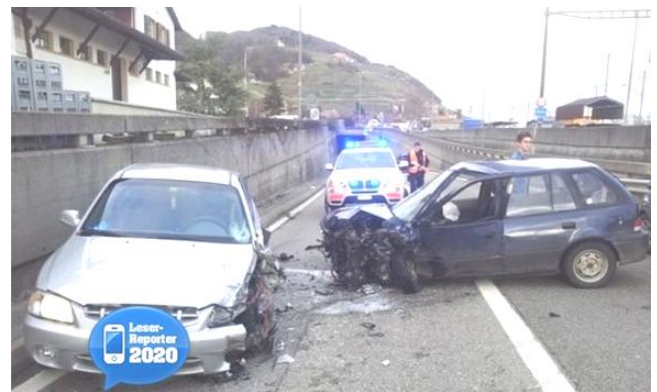
Fig. 1 Accident A5 Twann

Due to the small overlap the longitudinal bars of the vehicles are missed, the front wheels are separated from the suspension and pressed into the foot well. Thereby only very little energy can be reduced. If cars can't slide away sufficiently, the passenger compartment collapses due to the blocking.

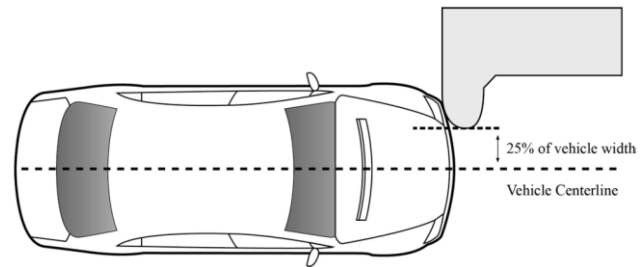
Fig. 3 Vehicle at the rigid IIHS Barrier

- 25 % overlap to a rigid barrier
- Impact velocity 64.4 +/- 1 km/h
- Dummy HIII 50% at the driver's designated seating position

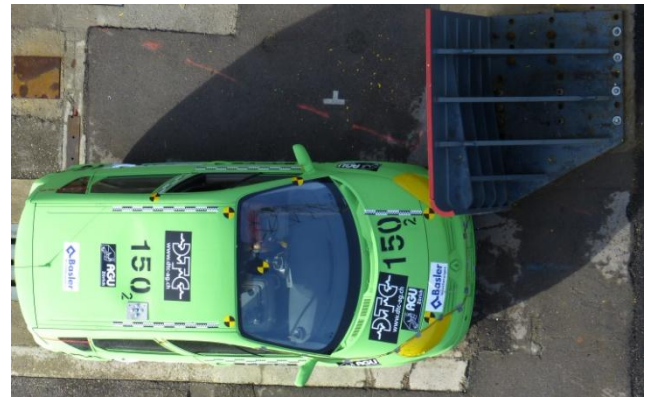
Fig. 4 Renault Scénic II at the rigid IIHS Barrier

The first crash test DTC 150 with a Renault Scénic II was carried out according to the instructions of the IIHS. The aim of the test was to study the behaviour of the selected vehicle in the small overlap IIHS Crash Test and also to compare the two-way traffic collision between two vehicles (DTC 151).

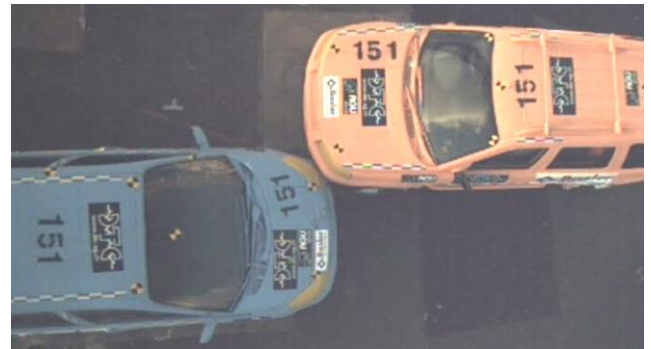
Fig. 5 Renault Scénic II against Landrover Freelander

A two-way traffic collision between a Renault Scénic II and a Land Rover Freelander was examined. The focus was on how well the structure and occupant loads on the Renault Scénic can be depicted by the IIHS small overlap crash test against a real accident. By using simulations of the accident analysis it could be determined that the impact should be conducted with at least 100 km/h relative velocity.

This simulation also showed that the two vehicles will slide off each other. Therefore, the energy input into the vehicle structure can't be substantially increased by further increase of the impact speed of the Renault Scénic II. The crash test was performed with 104.8 km/h speed and with coverage of 25% against a stationary Land Rover Freelander. The Land Rover Freelander was loaded on his gross vehicle weight with mass dummies and additional weight.

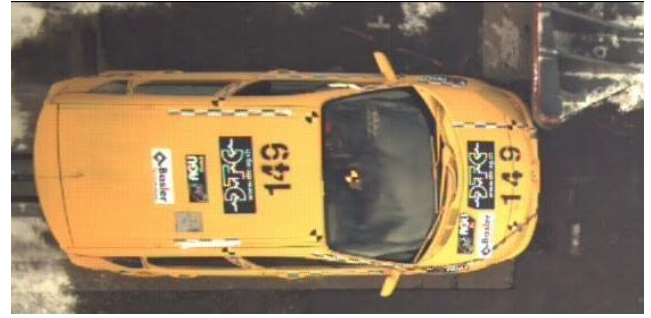
Fig. 6 Renault Scénic II at the IIHS barrier

To initiate at the rigid IIHS barrier a similar energy absorption in the front structure, the impact velocity of the crash test DTC 149 have been reduced to 46 km/h. This reduction applied only to the tested vehicle pairing Renault Scénic II - Land Rover Freelander. For other vehicles the corresponding impact velocity against the IIHS small overlap barrier can change depending on the body structure, vehicle mass, the stability of the passenger compartment and the longitudinal bar position.

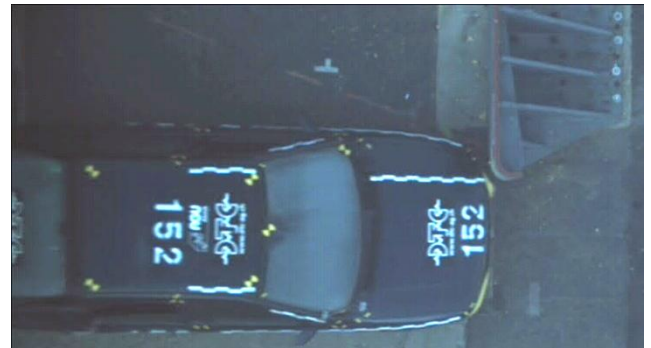
Fig. 7 Modified Ford Mondeo at the IIHS barrier

At the example of a modified Ford Mondeo the approach of slipping off was examined. Therefore the vehicle had been modified with steel profiles so that it can slip off the IIHS small overlap barrier and that the left front wheel is pushed inward before the passenger compartment meets the IIHS small overlap barrier.

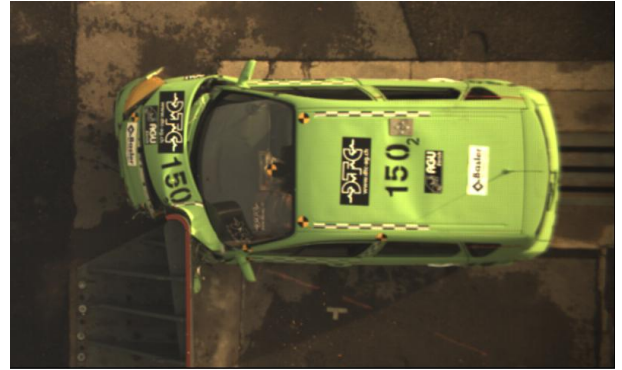
The vehicle hits the IIHS small overlap barrier with 65.2 km/h and an overlap of 25%. The Renault Scénic II grazed with the left longitudinal bar along the barrier in which only slightly energy is reduced. Also the left front wheel torn off and was pushed back against the foot well. The passenger compartment and the IIHS small overlap barrier finally form one block. The car didn't slide off and almost came to standstill on the barrier. The vehicle started to rotate about the z-axis.

Fig. 11 The left longitudinal bar doesn't hit the barrier

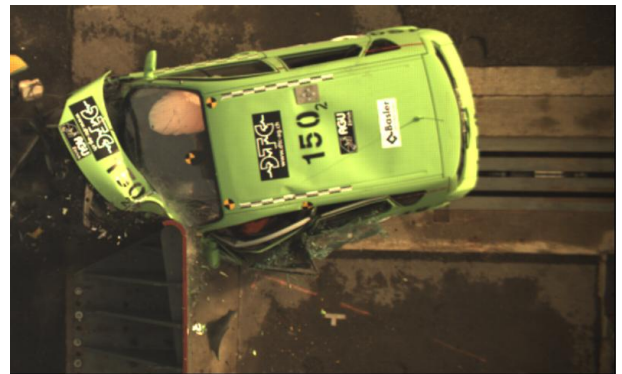
The passenger compartment collapses due to the hard impact. Because the left front wheel bends to the driver's foot well, it was severely deformed. As a result there were increased loads measured in the legs of the driver dummy. The passenger compartment deformed in such an extent that the dashboard to the left, the steering column and the steering wheel had been pressing into the interior. The restraint systems such as airbags and belt tensioners were triggered.

Fig. 12 The passenger compartment collapses

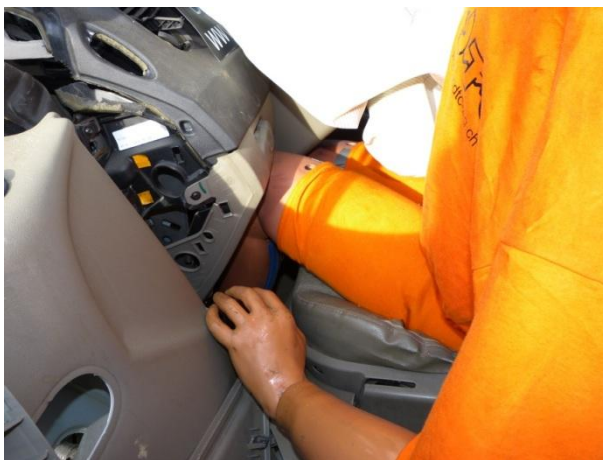
Because of the lateral displacement of the dashboard, the right knee of the dummy hit into the steering column, this results the higher pressure loads of the right femur. The biomechanical limits are not exceeded at the whole body.

Fig. 13 Reduced driver foot well

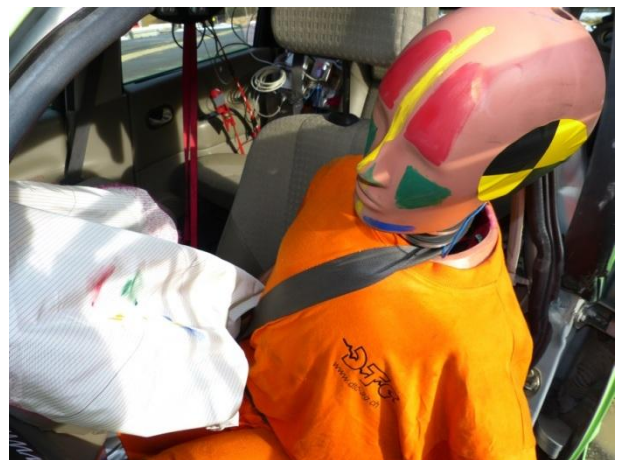
A very high injury risk to the lower extremities at the driver's place must be expected. Despite the rotative movement of the vehicle, the resulting direction of movement of the driver dummy and the displacement of the steering column, the dummy head still hits the front airbag. The restraint systems such as seat belts, belt tensioners and airbags could develop their protective effect.

Fig. 14 Marks of the dummy head at the airbag

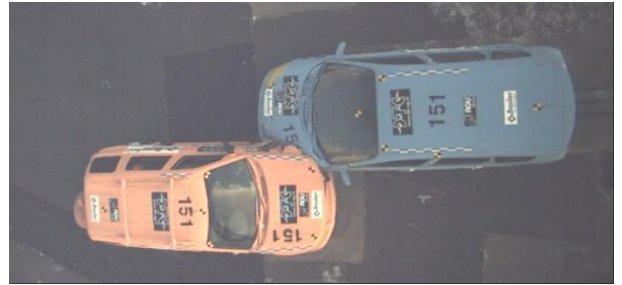
The Renault Scénic II hits the stationary Land Rover Freelander with 104.8 km/h and an overlap of 25%. The Renault Scénic II glided with the left longitudinal bar, far away from the longitudinal bar of the Land Rover Freelander, only through structural soft body parts. The wheels provided with their suspensions some resistance. Nevertheless, the longitudinal deceleration during the first 32 ms is on average 4.8 g, which is more than twice as high as in the barrier impact.

Fig. 15 The two longitudinal bars do not participate in the collision

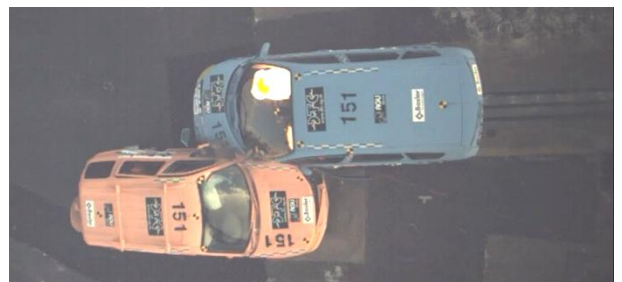
The closer the two passenger compartments came, the stronger they started to slide off. At the moment of the mutual contact of the passenger compartments, the belt tensioners and airbags from both vehicles were deployed. The left front wheels of both vehicles are demolished and pushed against the driver's side foot well.

Fig. 16 The vehicles slide off each other

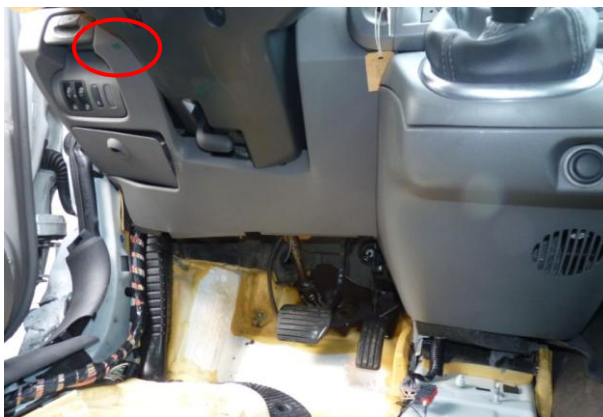
The driver foot well of the vehicle was slightly indented. On the instrument panel, a color print of the left dummy leg is shown. The driver's legs weren't trapped. The dummy head was well supported by the airbag in spite of vehicle rotation around the z-axis and the lateral displacement due to the sliding off. The two belt tensioners and the airbag could exert their protective effects very well. The measured loads were all over the body well below the biomechanical limits.

Fig. 17 Driver foot well

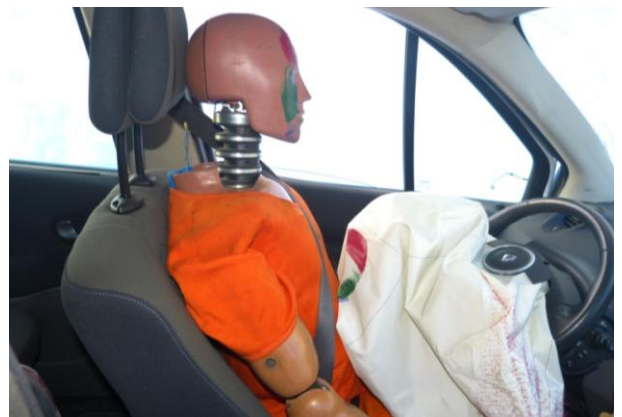
Fig. 18 Dummy head tracks on the airbag

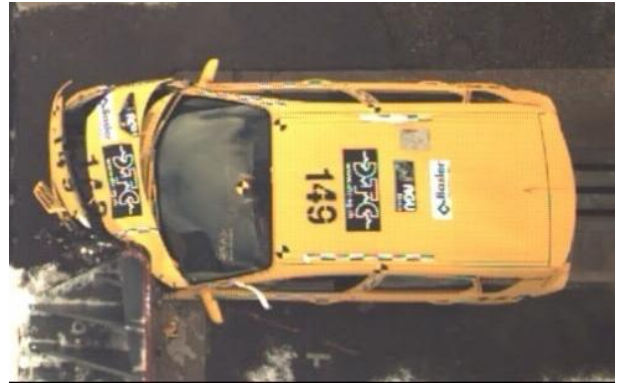
The vehicle hits the IIHS small overlap barrier with 46.7 km/h and an overlap of 25%. The Renault Scénic II grazed with the left longitudinal bar along the barrier. The longitudinal deceleration during the first 40 ms averages 2.5 g. Neither the pretensioners nor the airbags were deployed at this low level of deceleration. The battery ejected by the deformation of the front structure and separated from the vehicle.

Fig. 19 The longitudinal bar slides past the barrier

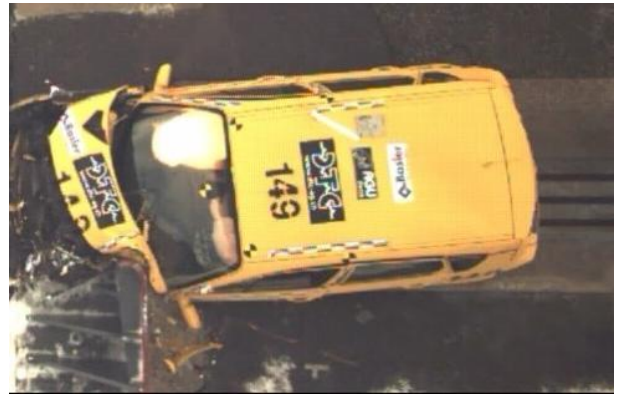
The car didn't slip off. The left front wheel was pressed into the driver's foot well and the passenger compartment has blocked on the IIHS small overlap barrier. The belt tensioners and airbags were deployed. By the acting rotation of the vehicle around the z-axis, caused by the collision, the movement of the dummy turns to the vehicle outside. The vehicle rotated more than 60° and stops three feet away from the barrier.

Fig. 20 Blocking of the compartment with the barrier

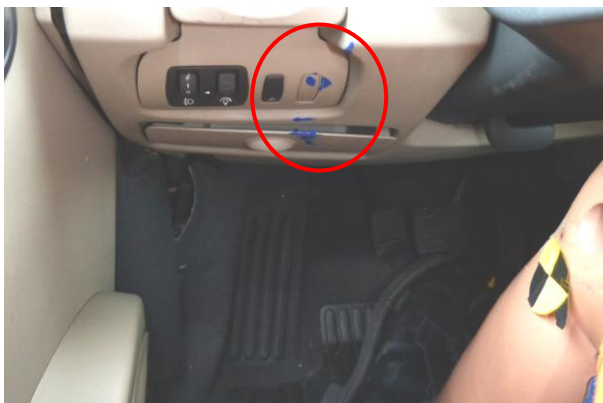
The passenger compartment has well resisted the impact onto the rigid barrier. The deformation of the driver's door shows that the limit of the energy input in the structure of the vehicle is reached at the low overlap of 25%. Because the longitudinal bar slid past the IIHS small overlap barrier, the defined deformation zone was mostly ineffective. Because of the two-way collision against the Land Rover Freelander matched impact speed of 46 km/h, the energy of the impact could be absorbed through the front outer structure, the left suspension and mainly by the blocking of the passenger compartment. Thereby the passenger compartment remained largely intact. On the instrument panel, color prints of the dummy legs are shown. The driver's legs weren't trapped. The measured loads were all over the body well below the biomechanical limits.

Fig. 21 Reduced driver foot well

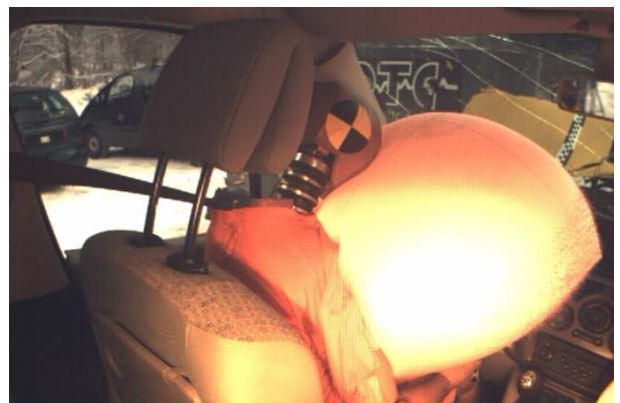
Fig. 22 Dummy head on the airbag

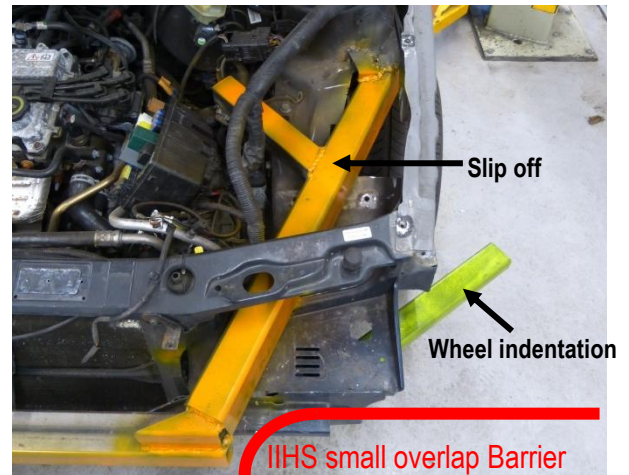
The modifications only serve to force the vehicle sliding off the rigid barrier. These implemented interventions in the front structure are not practicable in the present version. But they represent the two measures, which are necessary for a sliding in IIHS small overlap crash tests. The vehicle has been modified with various steel sections so that by the impact to the IIHS small overlap barrier a hooking can be avoided and that the wheel is pressed inward before the passenger compartment hits the IIHS small overlap barrier.

Fig. 23 Vehicel structure at the impacting area

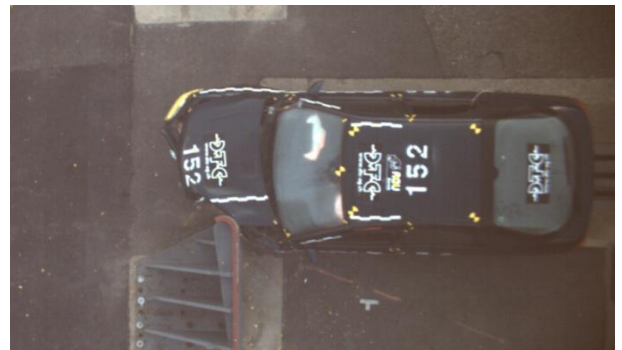
The vehicle hits on the IIHS small overlap barrier with 65.2 km/h and an overlap of 25%. First, the vehicle glided along the barrier with the left longitudinal bar to the extra fitted profile. Thereby much more energy was lost than in the tests DTC 149 or 150. With the modified structure, the vehicle started to slip off of the IIHS small overlap barrier and the front wheel was pressed inwards. The restraint systems such as airbags and belt tensioners were triggered.

Fig. 24 The front structure is pushed away from the barrier by the gains

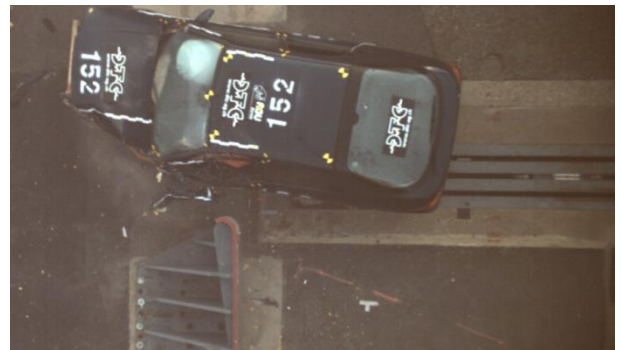
The vehicle loses only part of the energy by slipping off and has a remaining speed of 30 km/h after the collision.

Fig. 25 Different slip off kinematics

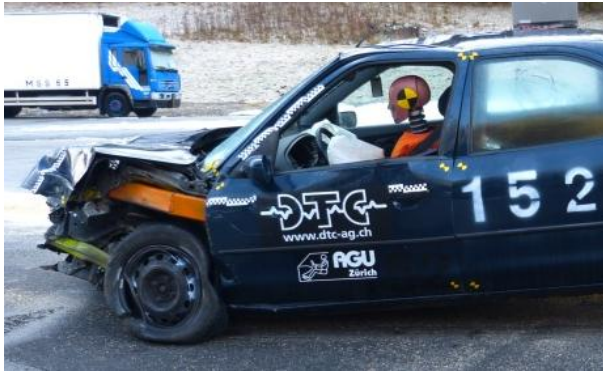
By slipping off of the vehicle on the IIHS small overlap barrier the passenger compartment remained largely intact. Furthermore it was prevented that the left front wheel got hooked and torn off. It should be noted that the structure of the vehicle is not designed for the Euro-NCAP (compare Fig 8 to 10) due to its old model age.

Fig. 26 Mostly intact passenger compartment and foot well

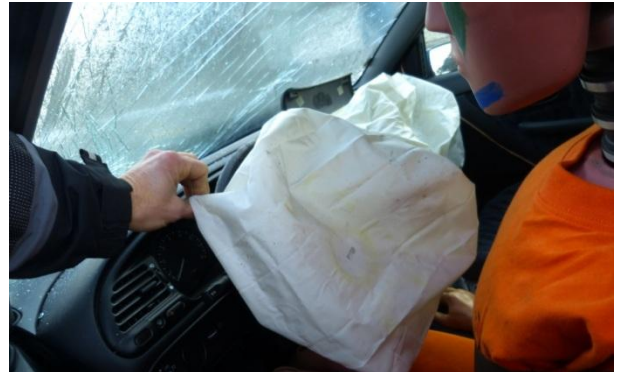
Due to the lateral movement of the vehicle and the transverse movement of the dummy, he did not hit the front airbag. The used vehicle was equipped with first-generation airbags and no side airbags. The measured loads were, compared to the preceding crash tests, generally the lowest and at the whole body substantially below the biomechanical limits.

Fig. 27 The front airbag was missed

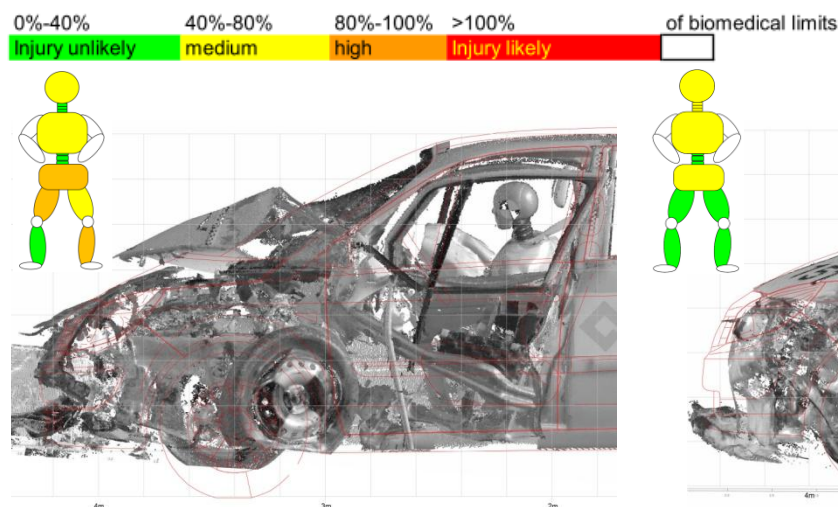
The left two longitudinal bars of the vehicles could not be supported in both types of collisions due to the small overlap of 25%, and were therefore not involved in the energy absorption. By the Renault Scénic II, also the upper longitudinal bar below the fender is barely deformed. A hard impact on the passenger compartment at the bottom of the A-pillar was not observed in the two-way traffic collision. Nevertheless, the impact energy, until the passenger compartment was involved, respectively until the slip off, could be reduced so that the survival space for the occupants remained for the most part intact. In tendency the structural loads from the two-way traffic collision (DTC 151) are comparable with those from the small overlap IIHS crash test (DTC 150) at 64 km/h. Because of the slipping off and the thereby missing impact of the passenger compartment on the Land Rover Freelander (DTC 151), the deformations and the occupant loads in the two-way traffic collision were significantly lower at the pelvis and lower extremities than the impact of the rigid barrier.

Fig. 28 Passenger compartment after IIHS small overlap Crash DTC 150

Fig. 29 Passenger compartment after two-way traffic collision DTC 151

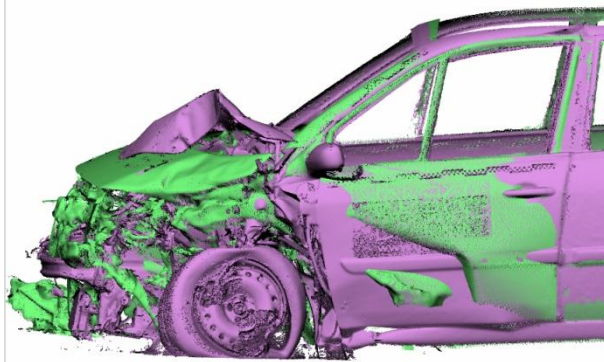
The Renault Scénic II at the IIHS small overlap crash test with reduced velocity hooked to the barrier. The left longitudinal bar was not hit by the rigid barrier. The upper longitudinal bar, underneath the fender, was in contrast to the oncoming traffic collision (DTC 151) with the Land Rover Freelander, completely deformed. Despite the small overlap the impact energy could be mainly absorbed up to the passenger compartment, so that the survival space for the occupant is still largely intact. Similar to the two-way traffic collision (DTC 151) the driver's side foot well was lightly deformed by the broken wheel.

Fig. 30 Overlay of the both vehicle deformation IIHS Barrier DTC 149 (violet) und two-way traffic DTC 151 (green)

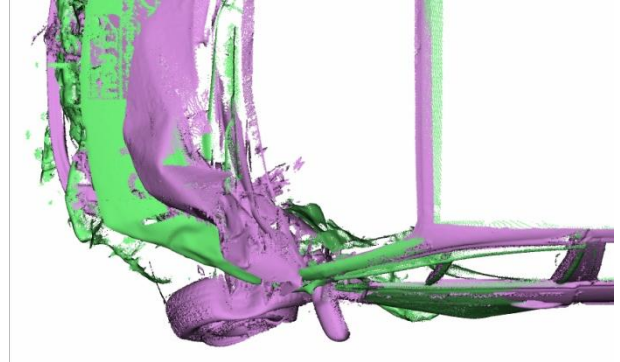
Fig. 31 View from the top

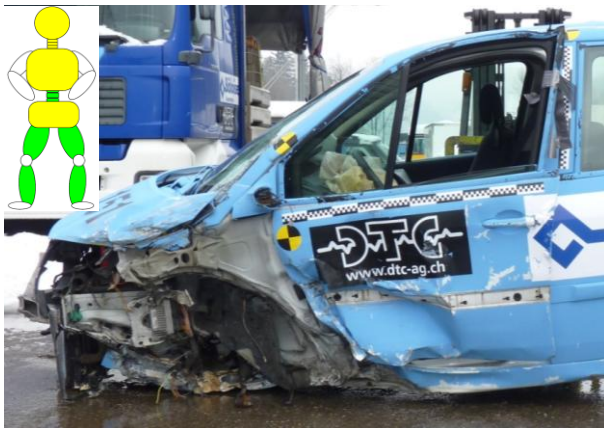
In the left leg of the driver dummy the measured pressure was slightly higher than in the right leg. The measured loads were in both tests on the whole body well below the biomechanical limits. Only the 3 ms head acceleration was slightly higher compared to the oncoming traffic collision. This can be established on one hand, due to the higher collision induced velocity change and secondly due to the higher rotation of the vehicle about the z-axis (DTC 149: 11.0° / DTC 151: 5.2°) and therefor is an unfavorable support of the head to front airbag.

Fig. 32 Passenger compartment after two-way traffic collision DTC 151

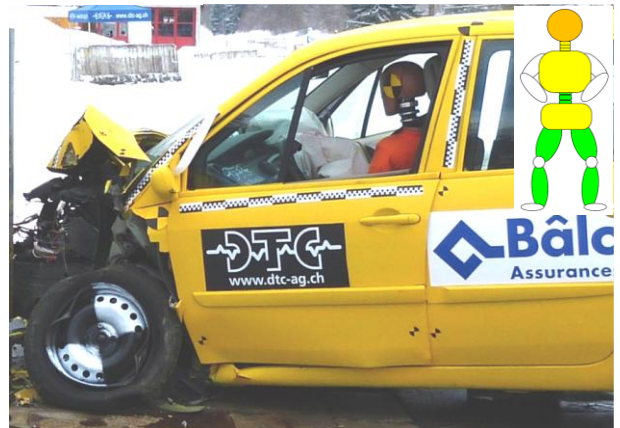
Fig. 33 Passenger compartment after IIHS small overlap Crash with reduced velocity DTC 149

The crash test DTC 149 has shown that the structure- and occupant load of the two-way traffic collision between the Renault Scénic II and a Land Rover can both be simulated at the IIHS rigid barrier. For the Renault Scénic II that would require a reduced impact velocity of 46 km/h.

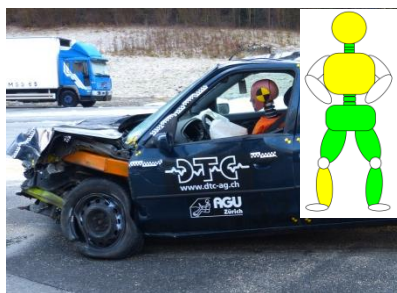
After the deformation of the front structure the Ford Mondeo has slipped off the IIHS small overlap barrier because of the additional built-in structure parts. A hard impact to the passenger compartment at the bottom of the A-pillar did not happen, so that the survival space for the occupants remained largely intact. Airbag and belt tensioners were triggered. The restraint systems could develop their protective effect, but only conditionally. By the sudden slip off and the resulting lateral movement of the vehicle the driver dummy missed the front airbag due to its inertia. But thanks to the belt retention the head did not hit the instrument panel or the vehicle structure. In comparison to the Renault Scénic II, the Ford Mondeo has much narrower space in the foot well. Therefore slightly elevated pressures were measured in both legs of the driver dummy. The measured loads were all over the Body the lowest and well below the biomechanical limits.

Fig. 34 Driver compartment after IIHS small overlap crash with slip off DTC 152

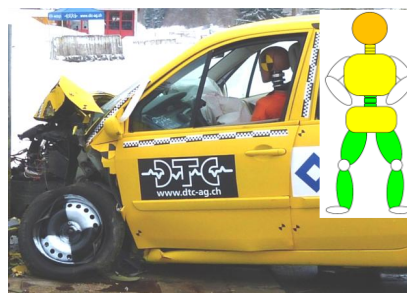
Fig. 35 Driver compartment after IIHS small overlap crash with reduced velocity DTC 149

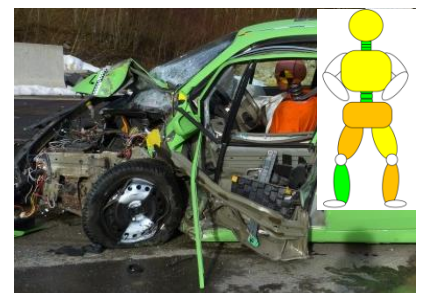
Fig. 36 Driver compartment after IIHS small overlap crash DTC 150
